Misalignment cases on machine trains of CC Power Plants

Francesco MINIELLO¹, Nicolas PETON²

¹GE Oil&Gas – Digital Solutions, c/ Valcarcel 26, Madrid (Spain)

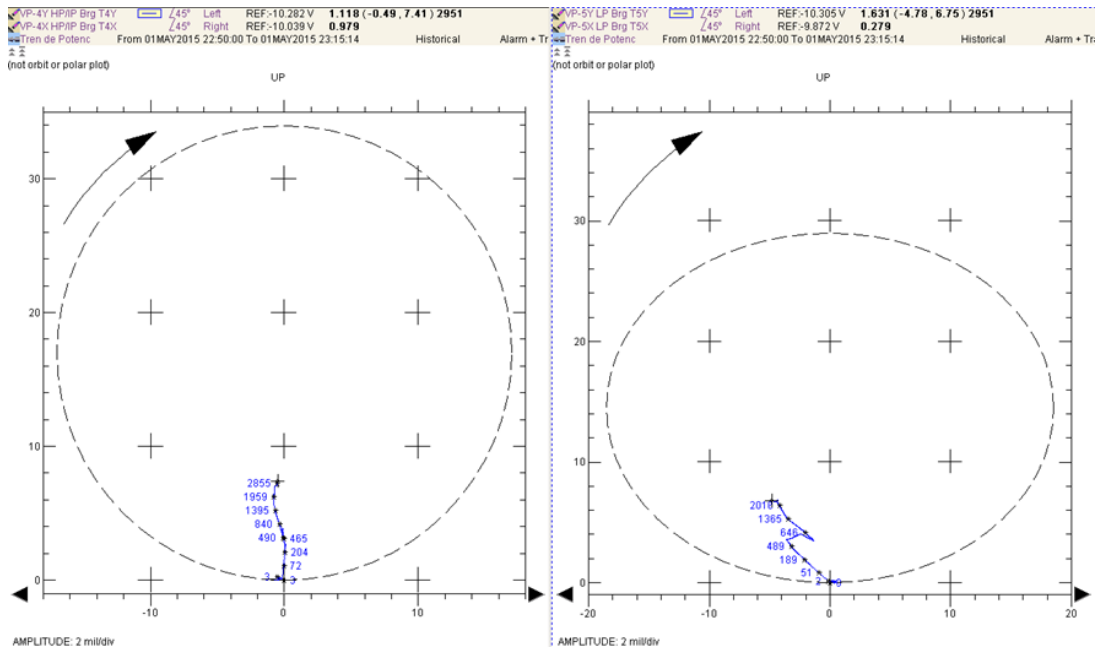
The SCL plots of the SU (from turning gear speed up to nominal speed) was analyzed; this plot, configured with the real diametrical clearances, revealed that actually Bearing 4 was more loaded than normal, as the position of the shaft at the end of the SU was significantly lower than expected for a tilting pad bearing [2] (Figure 3). This information indicates a possible misalignment between ST HP/IP and ST LP, but other aspects should be taken into consideration to diagnose external misalignment.

In fact, external misalignment can be confirmed when a heavily loaded bearing is associated with a lightly loaded bearing [1]. For this reason, the SCL plot of Bearing 5 was analyzed. This bearing is an elliptical bearing, and the final position of the shaft at the end of the start-up appeared to be too high, confirming that this bearing was abnormally unloaded.

Figure 3. SCL plot measured at Bearings 4 and 5 during the SU

The maintenance team was asked to check the alignment between ST HP/IP and ST LP when possible. During the first available stop, the alignment condition was measured, and it was found a strong misalignment, as expected. Despite of the evidence, there was no time to improve the alignment condition, as the downtime of the unit had to be limited. As already mentioned, the alignment of these single shaft trains require several days, and the plant personnel took the decision to maintain the unit in a misaligned condition.

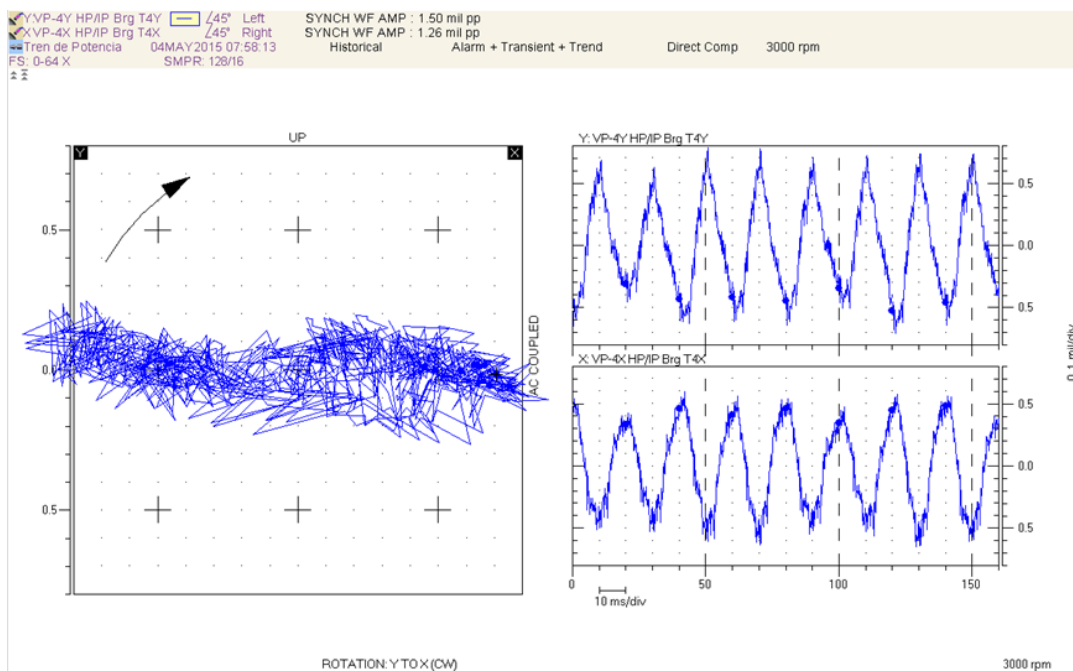
Interesting enough, the orbit patterns totally reflect this situation; at Bearing 4, the compensated orbit was very flattened (Figure 4), and its major axis almost horizontal, confirming the existence of a radial preload acting in the vertical direction. At Bearing 5 instead was observed a circular orbit pattern (Figure 5),

Figure 4. Direct compensated orbit at Bearing 4 on Load

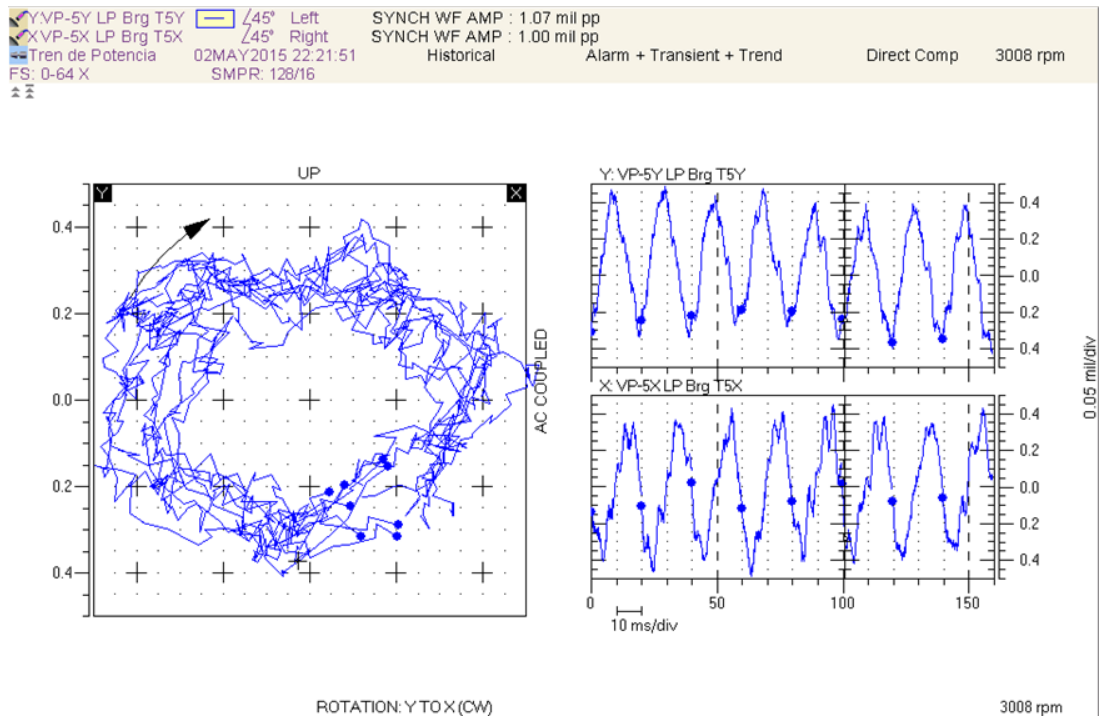
which is indicative of a lightly loaded bearing; normally in fact the elliptical bearings exhibit a quite elliptical orbit when are properly loaded.

Figure 5. Direct compensated orbit at Bearing 5 on Load

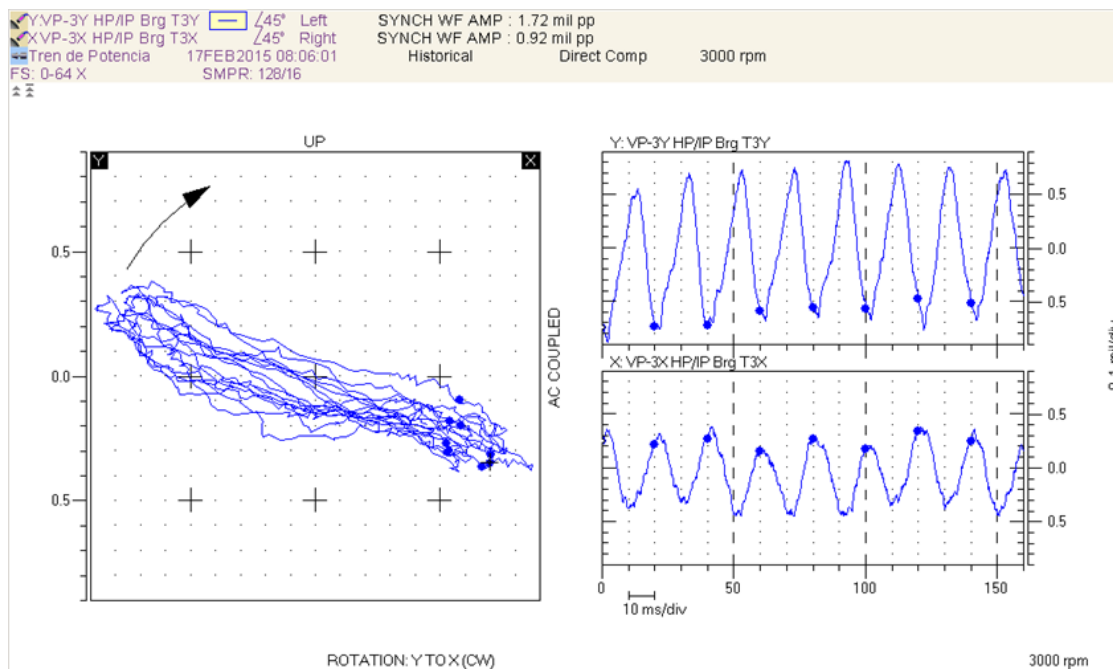
After the overhaul of the unit, the orbit pattern at Bearing 3 (ST HP/IP) became very flattened when on load. There are several reasons why an orbit can be flat: high preload (due to external or internal misalignment), split resonance, mix mode, important anisotropy for example.

Figure 6. Direct compensated orbit measured on load at Bearing 3, showing a flattened shape.

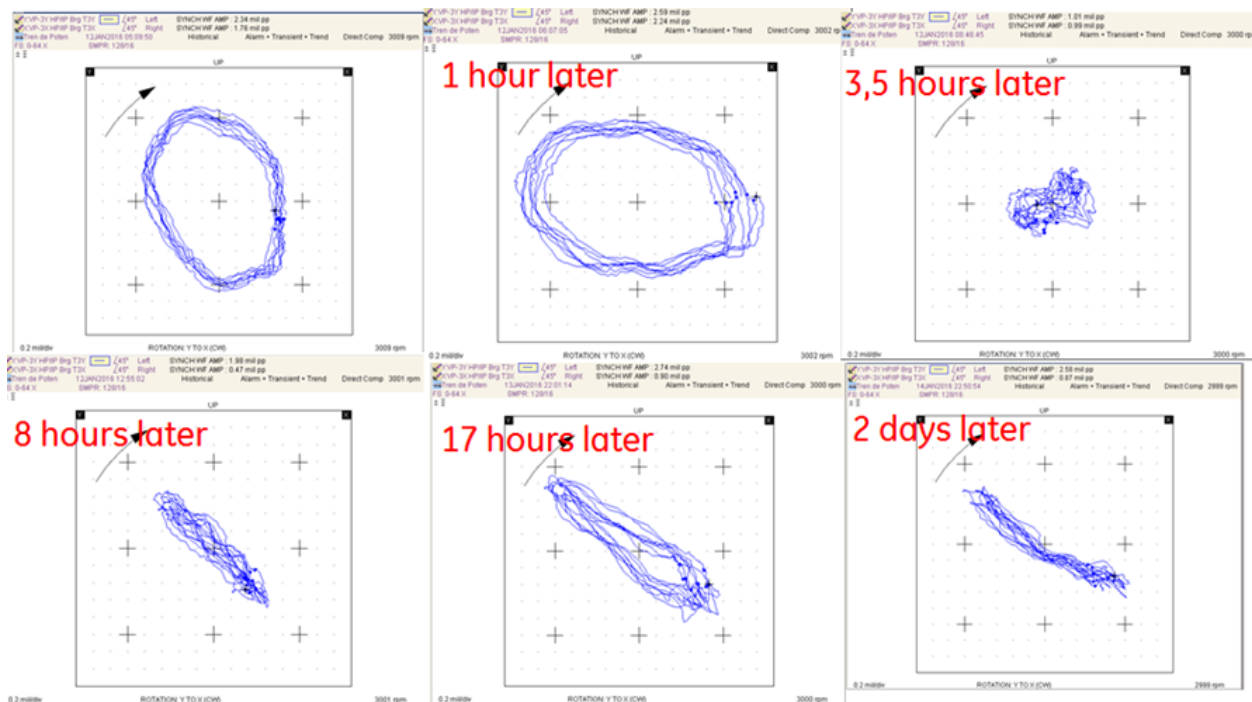
To rule out some of the mentioned possible causes, it is important to observe that, just at the end of the speed increase (at 3000 rpm), the orbit pattern was rather circular. Then, during the thermal transient (which normally takes about 6-8 hours) the orbit pattern used to become more flattened, and even show an “eight shape” resulting finally in a very flattened shape after the thermal transient, as mentioned above (Figure 7).

Figure 7. Evolution of the orbit shape at Bearing 3 from no load condition until the end of the thermal transient.

For this reason, it was suspected that the unit was affected by a problem of misalignment between GT and ST, magnified by the effects of the thermal gradient, which was causing their relative position to be more offset than in the cold condition, and therefore increasing the preload on Bearing 3.

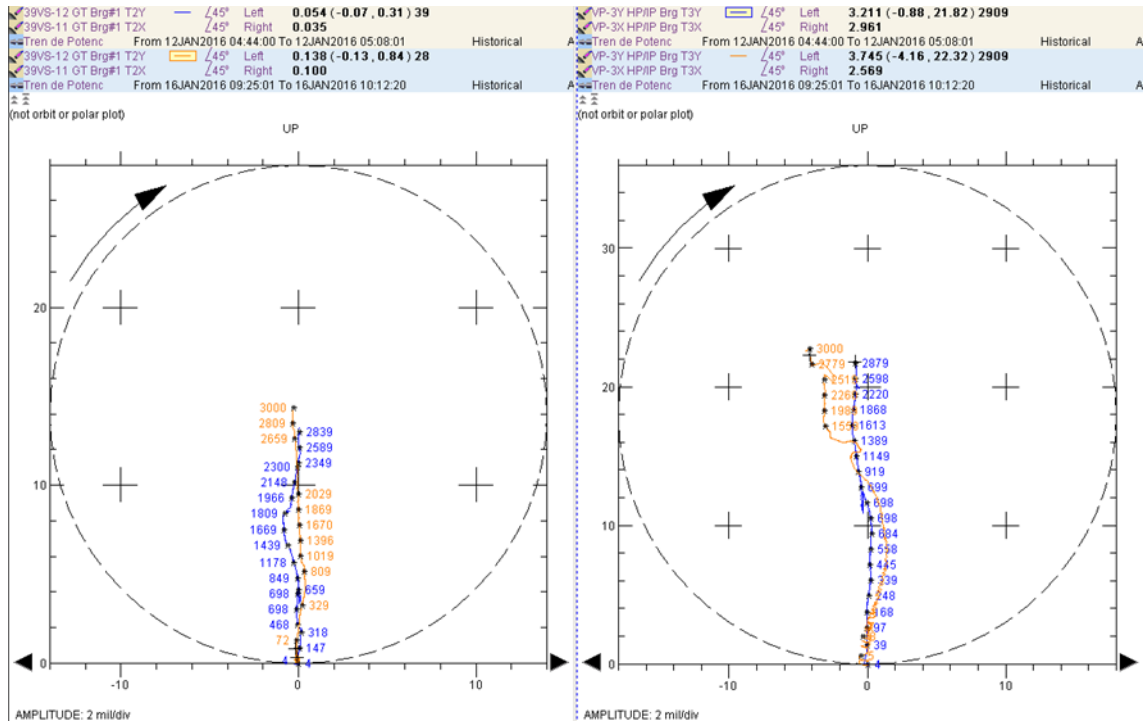
To further investigate this hypothesis, the Shaft Centerline (SCL) Plot, configured with the real diametrical clearances, was observed. It was plotted the SCL path for the coupled Bearings 2 and 3 during a start-up (in blue in Figure 8) overlaid with the path during a shut-down (in orange). The position of the SCL at the end of the start-up can be considered normal taking into account these are both tilting pad bearings [2].

On the other hand the comparison between SU and SD gave a hint of the effect of the thermal transient on the SCL position. The plot suggested that Bearing 2 becomes more unloaded after the thermal transient, and in fact the bearing metal temperature used to decrease from 95° to 90° in few hours, remaining then steady.

The analysis for Bearing 3 is instead more complicated. The curves seem to suggest that also this bearing was becoming more unloaded, which does not really make sense, as in case of high preload between bearings, an unloaded bearing is always associated to a loaded one [1].

Figure 8. SCL plot measured at Bearings 2 and 3 during the SU (in blue) and during the SD (in orange). Compensation at slow roll speed.

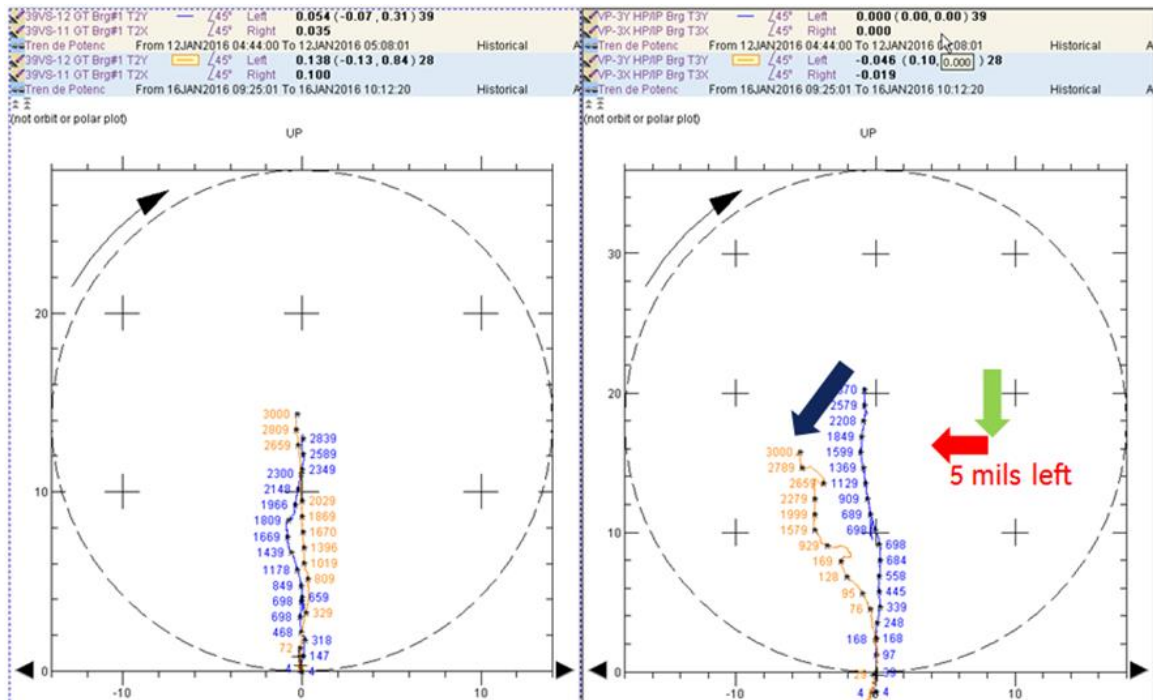
One good way to avoid this unwanted effect is to compensate the SCL of the shut-down curve at a speed which is not yet affected by temperature (of course the SU curve must be compensated at that same speed to compare). This trick reveals that actually after the thermal transient Bearing 3 becomes more loaded, as the SCL goes downwards and toward the left. The left movement can be quantified in around 5 mils (Figure 9).

Figure 9. SCL plot measured at Bearings 2 and 3 during the SU (in blue) and during the SD (in orange). Compensated to avoid the effects of temperature on position measurement.

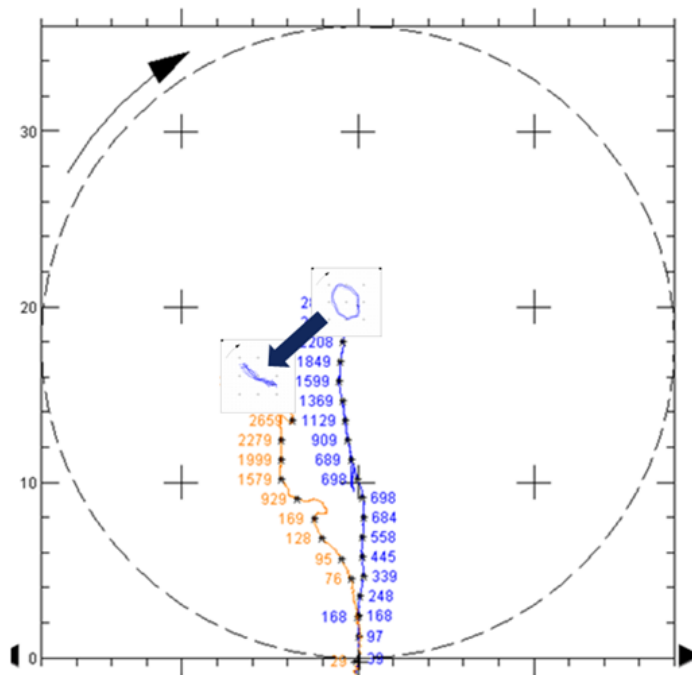
Overlaying the SCL and the orbit, the complete picture can be obtained (Figure 10). At FSNL, the shaft operates in the center of the bearing (slightly unloaded) and the orbit has a rather circular orbit. After the thermal transient instead, the increase of load with a strong component in the left direction causes a restriction of the shaft vibration in the same direction, and therefore the mentioned flattened pattern. It is important to observe that at Bearing 3 the metal temperature is not indicative of any bearing load change, as

Figure 10. The complete picture: shaft position and dynamic movement at Bearing 3 before (blue) and after (orange) the thermal transient.

A comparison with the behavior of this bearing before the overhaul, revealed that the progressive loading (=downward movement) of the bearing was also observed in the past, nevertheless the movement towards the left direction became significantly bigger after the overhaul (it went from around 1,5 mils to around 5 mils). The data measured on a sister unit also confirmed that a leftward movement of about 1-1,5 mils is normal for this bearing.

All this led to the conclusion that the leftward movement was indicative of a misalignment condition between GT and ST HP/IP, being this misalignment strongly influenced by the thermal growth of bearing supports and pedestals. The root cause of this misalignment could be due to a wrong (= out of tolerance) alignment in the cold condition and/or to an excessive thermal growth.

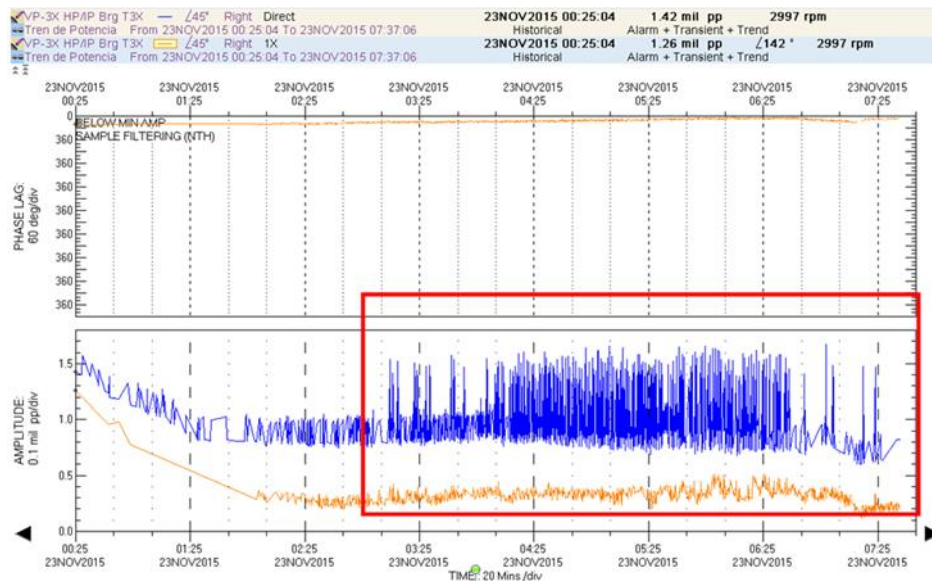
After more than one year of misaligned condition, a new phenomenon started to appear. During the thermal transients at Bearing 3 it started to be observed an oscillation of the direct levels of vibration (Figure 11). As observed in the spectra, these oscillations were due to very low frequency vibration – the phenomenon used to last few minutes at the beginning, but after several months it used to last about 4 to 6 hours, always during the thermal transient period.

This behavior was diagnosed as a worsening of the bearing condition, possibly a looseness between the bearing and the casing, due the action of high preloads during many months of operation.

The inspection of the bearing revealed that there was a significant looseness in the bottom part of Bearing 3, between the bearing itself and the casing. This looseness is not considered normal (this bearing is normally mounted with interference), and is indicative of a wear process which was developing with time.

The analysis carried out above indicates that this wear process was caused by the abnormally high preloads acting on the bearing. The bearing was repaired and then properly mounted.

Figure 11. Direct vibration and 1X trends measured at Bearing 3 during the thermal transient. The direct amplitudes oscillate during the thermal transient.

For all the above, it was recommended to check the alignment condition and Bearing 3 condition.

The maintenance operations done during the first available outage found a misalignment between GT and ST HP/IP. The rim-face readings indicated a strong misalignment, which was improved up to a level considered acceptable, but still slightly out of specs. This compromise decision was taken in order to minimize the downtime of the unit.

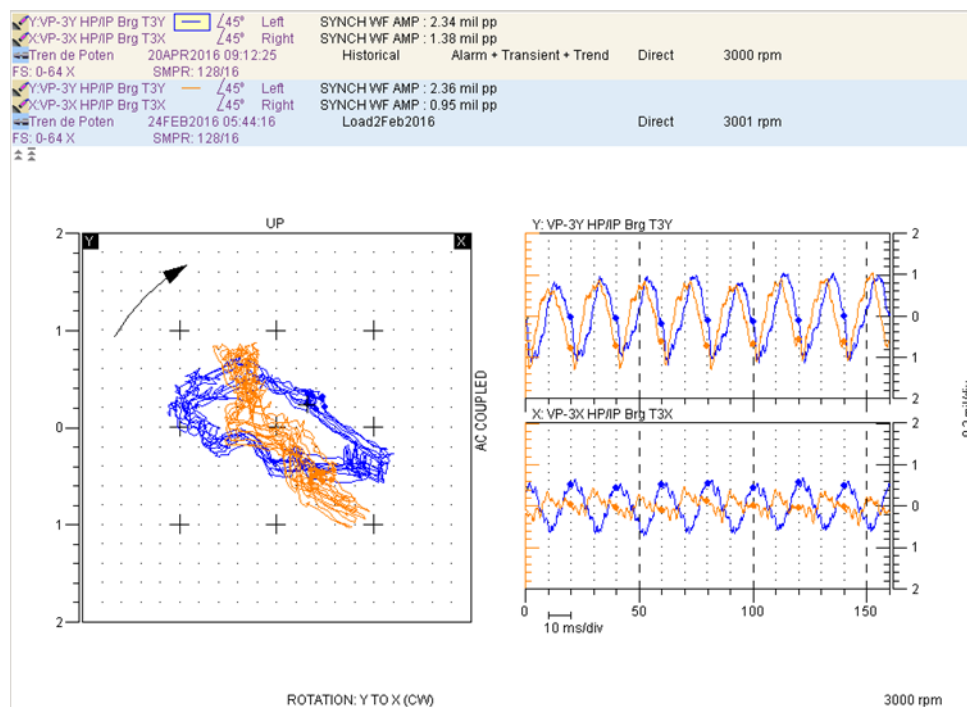
Moreover, the orbit pattern on load at this bearing after the thermal transient became much less flattened than before the outage (Figures 12 and 13), indicating a reduction of the preloads in the new mechanical condition. This analysis was confirmed by the SCL plots: the comparison between the new SU and SD curves at Bearing 3 indicated that the leftward movement was reduced up to 1 mil, a value considered normal for this bearing (Figure 14).

Figure 12. Direct uncompensated orbits overlay – Orbits measured at Bearing 3 on load before (orange) and after (blue) the alignment.

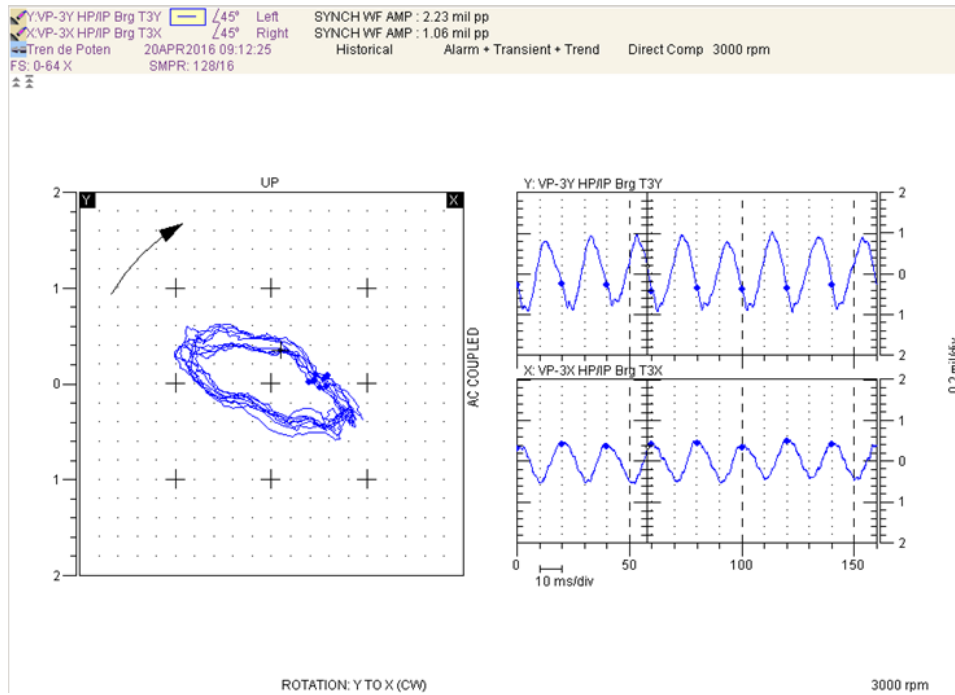
Figure 13. Direct compensated orbit on Load at Bearing 3 after the alignment.

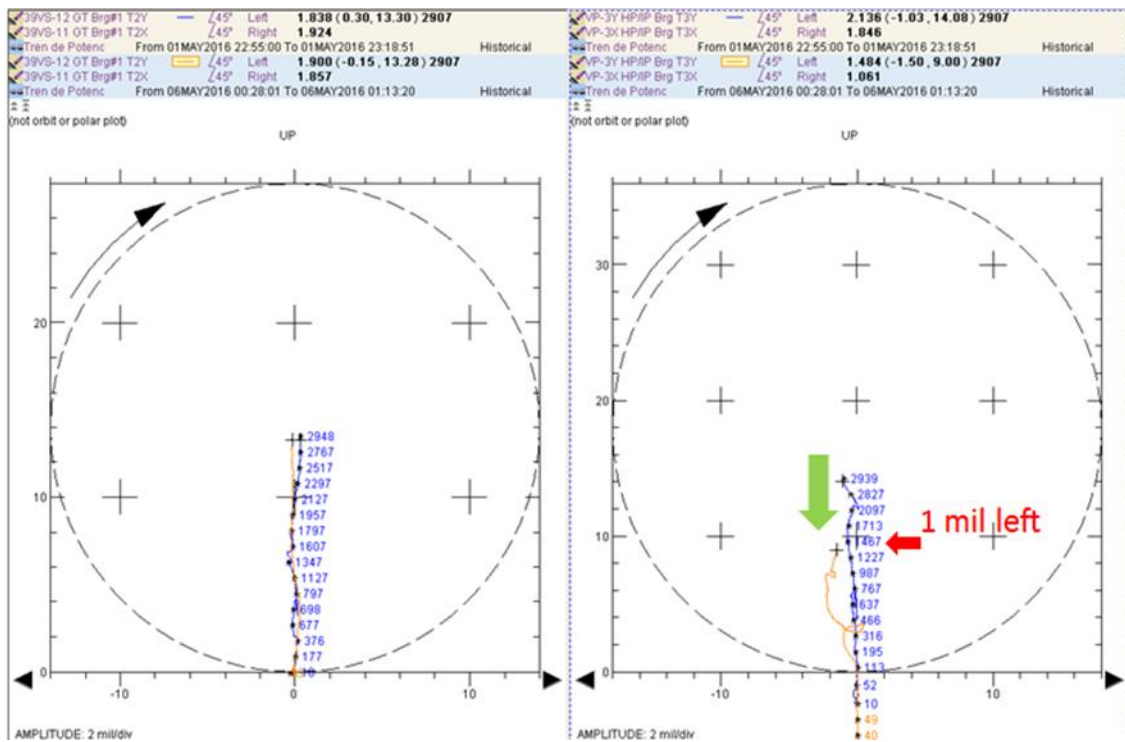
Figure 14. SCL plot measured at Bearings 2 and 3 during the SU (in blue) and during the SD (in orange) after the alignment. Compensated to avoid the effects of temperature on position measurement.
