# Investigative techniques for detecting torsional stresses of shaft lines of a ball mill

## Abstract

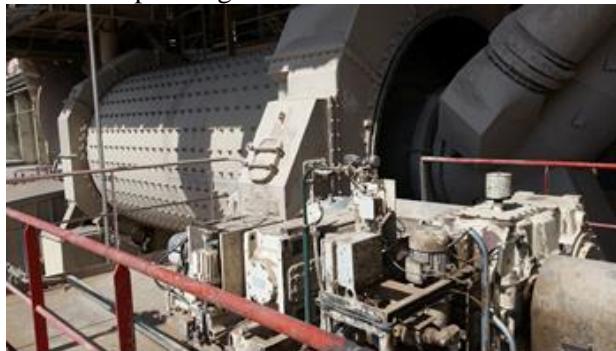
Figure 1: the picture of the Mill

In this paper we propose the case study of torsional vibration of a ball mill used for cement manufacturing process. A picture of the mill is shown in Figure 1. The main mechanical elements consisted of an asynchronous motor with electrolytic resistance starter, a two-stage reducer gearbox, and a pinion / girth gear for the drive of the mill.

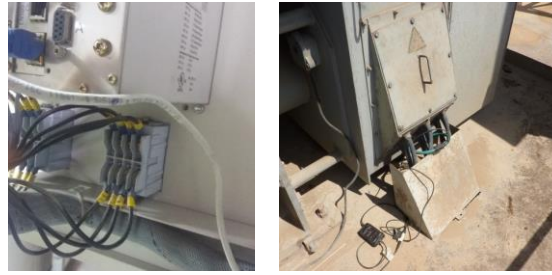
Figure 5 : measurement of Stator current and Rotor current

The stator current measurement was carried out from the CT (1: 200 ratio) see figure 5 right picture and the rotor current measurement from the rotor terminal box see figure 5 left picture.

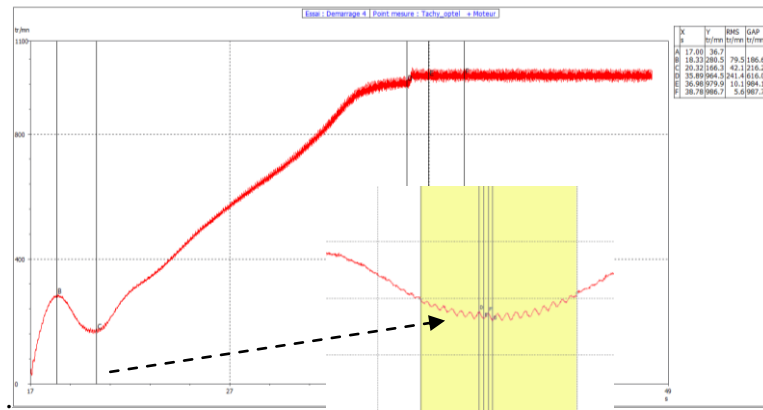
Figure 10 - Instantaneous speed

The measurements of the instantaneous speed of the input shaft of the gearbox reveal several phases (the figure 10):

A first phase of acceleration about 1.3 seconds,

A deceleration phase of about 2 seconds between marks B and C of the curve below, This is due to a high load phase before material begin to move in the mill shell.

A second phase of acceleration between the marks C and D,

Phase of rotor short-circuit which reach its nominal speed (between the marks D and E).

The zoom around the mark C in figure 10, shows the speed fluctuations on the first startup seconds. The zone identified as having strong torque fluctuations clearly show fluctuations in the instantaneous velocity due to the torsional resonance. These fluctuations are 14 rpm for a shaft input speed of 172 rpm (8%).

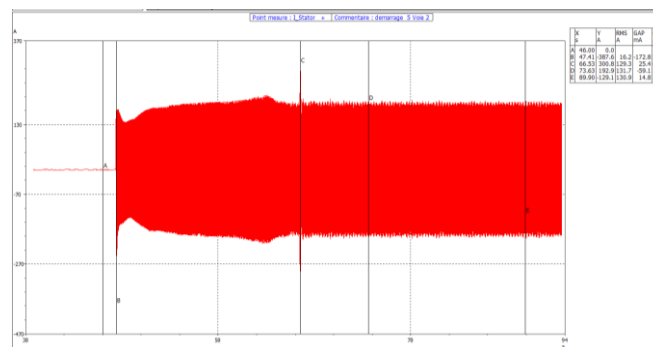
Figure 12 – raw signal of a stator current

The raw signal of a stator current is shown in figure 12. In this illustration, only two maximum peaks are identified. The first peak correspond to the start (mark B) when the motor is energized and second peak is corresponding to the rotor rings short circuited (mark C). During the run-up, no natural frequency is observed in the stator current signal. However, at stabilized speed, the amplitude demodulation spectra around the grid frequency at 50 Hz clearly show a dome of energy at 12.4 Hz corresponding to the torsional mode which is not excited by any kinematic frequency. This spectrum is illustrated in figure 13.
